# SAFETY ALERT

## Technical Bulletin 07012020

### Subject: High-Pressure Gauges sold between 2012 and 2018

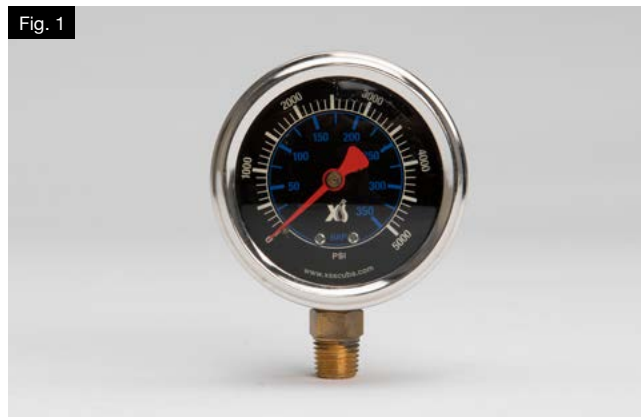
Fig. 1

**How to Identify:** The GB01 HP gauges in question have a black face card with an outer white scale in psi, and an inner blue scale in bar. They are filled with a clear oil. They have 1/4" NPT threads (Fig. 1).

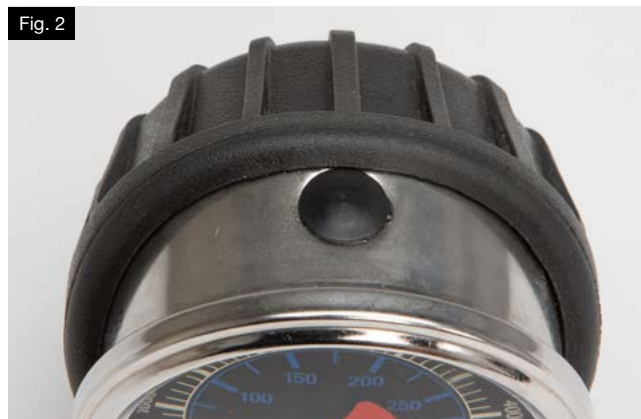
Fig. 2

**The Problem:** In the rare event of an internal leak, the black over-pressure (OP) relief plug (Fig. 2), located on top, should vent, allowing excess pressure to escape. It does not in all cases.

We are finding that as these over-pressure plugs age, they are becoming harder. While originally supple and pliable, some that have been in the field for many years have become hard. In some cases, we found that the plug had become too hard to properly relieve excess pressure should there be an internal leak. This can result in the glass lens shattering outward.

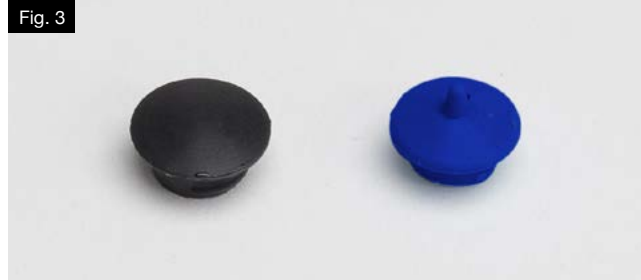
Fig. 3

**The Solution:** XS Scuba has a replacement OP plug available, which will not harden with age. To visually distinguish the two, the upgraded replacement plug is blue, while the old plug was black (Fig. 3).

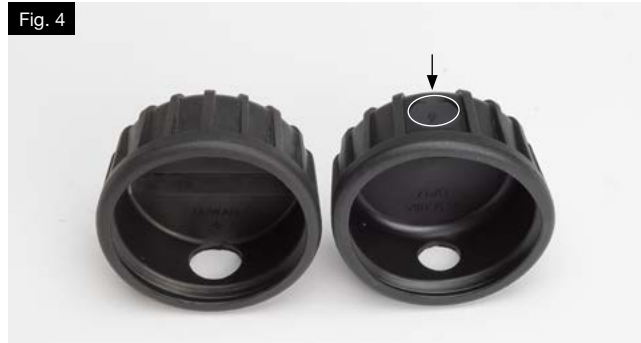
Fig. 4

In addition, if your High-Pressure Gauge has an older style, protective rubber boot that does not have a relief hole on top, XS Scuba will provide an updated boot for you. The relief hole allows the OP plug to release without interference (Fig. 4).

If the gauge's rubber protective boot does not have a 1-inch relief hole on top, centered over the OP plug, remove the boot and replace with the upgraded model (Fig. 4).

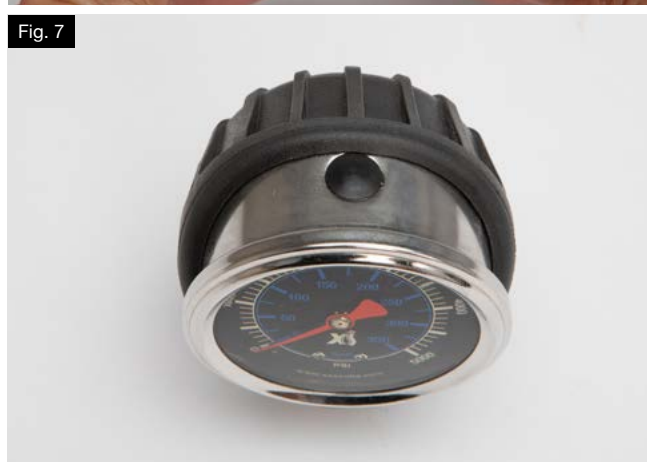
Email a simple picture, taken with your phone, of each suspect HP gauge in your possession. Peel back the rubber protective boot, exposing the OP Plug. Shoot the gauge from the front, at a sharp downward angle (Fig. 7). The image should show the front face card, the black OP plug, and the top of the rubber protective boot.
